## NASA Reference Publication 1122

# Procedures for Precap Visual Inspection

Office of the Chief Engineer National Aeronautics and Space Administration Washington, D.C.

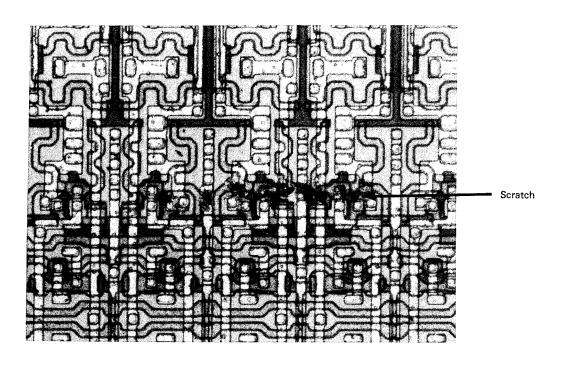
Figure 14a is a photomicrograph of a VLSI memory device with a defect that is difficult to distinguish under the precap examination criteria of 100X to 200X. If the magnification is tripled, the defect shows up as a disturbed area (scratch) of metallization (fig. 14b). The scratch resulted in an open-circuited metallization stripe that caused the device to malfunction. Because examining complex devices at higher magnifications requires an amount of time that is not normally available to a precap inspector, the following paragraphs will address those metallization defects that are easily observable at 100X to 200X.

Figure 14. Photomicrographs of a VLSI device.

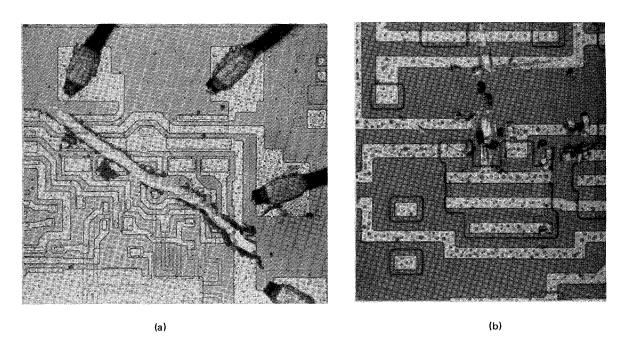
Two of the most common kinds of metallization defects are scratches and voids. A scratch (fig. 14b) can be defined as any tearing defect, including probe marks, in the surface of the metallization. Scratches most often result from mechanical or mishandling damage; wafer probing is one source of scratches in metallization (fig. 15). Each circuit on a silicon wafer is electrically tested (either on a 100 percent basis or by sampling) after contact is established by means of fine-pointed micropositioned probes. (This test is performed to screen out bad devices before packaging.) The actual motion of the probes is mechanically controlled by an operator or automatic test equipment. This motion often results in a scrubbing motion that causes scratches in the metallization. Because it is softer than other metal systems (i.e., titanium/tungsten and gold/molybdenum), aluminum is particularly susceptible to scratching, smearing, and other deformations.

Figure 15. Metallization scratches.

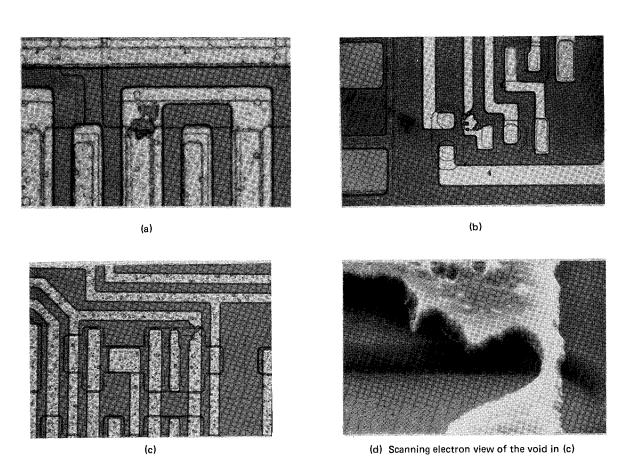
Voids are the result of an inadvertent etching of the metallization in the photolithographic process. A void can be defined as any region in the metallization where underlying metal or passivation is visible that is not caused by a scratch (fig. 16). The inadvertent etching

Figure 16. Voids in metallization stripes.

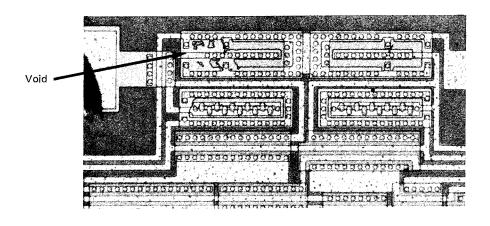
Figure 17. Void in a polysilicon gate.

- A scratch or a void in the metallization stripe that reduces the width of the metallization stripe to less than one-half of the minimum designed width (fig. 16c).
- A scratch in the metallization over a passivation step that leaves less than 75 percent of the original metal width at the step undisturbed (fig. 16a).
- Void(s) in the metallization over the gate oxide bridge that leaves less than 75 percent of the metallization length and width between the source and drain diffusions undisturbed (fig. 17).

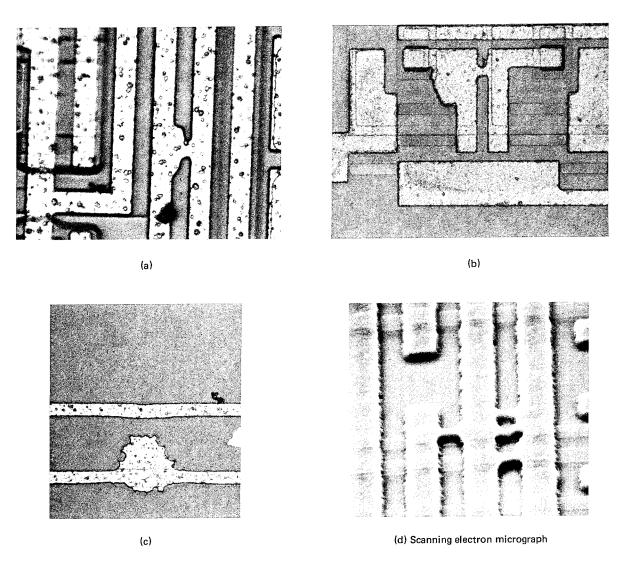
Bridging metallization is the result of incomplete etching during the photolithographic process. Two conditions can occur from this type of defect:

The first defect produces a direct short circuit and is detectable during a precap examination or electrical tests. The second phenomenon often escapes visual detection and is usually not detectable electrically. If the die is not glassivated or if the glassivation is of high porosity, high moisture content in the package

Figure 18. Bridging metallization.

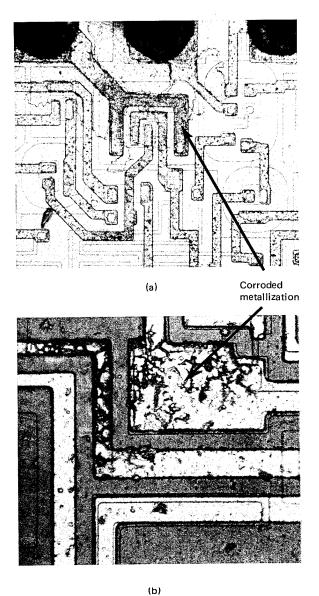
Another latent electrical problem is the open circuiting of metallization due to corrosion of the aluminum (fig. 19). Occasionally during manufacturing, the metal etching solution is not completely rinsed off the surface of the die, leaving salts deposited along the edge of the metallization stripes. In addition, if

Figure 19. Corrosion of aluminum metallization.

any photoresist is left on the die, the salts may become entrapped in the resist. In the presence of very small amounts of residual water vapor in the sealed package or water vapor from definite package leaks, the salts react with the aluminum. Aluminum normally has a stable oxide and is therefore self-passivating. In the presence of ionic contaminants (sodium and chloride), the oxide can be broken down and attacked. An additional source of aluminum corrosion is phosphoric acid. If there is too much phosphorus (>6 percent) in the phosphosilicate glassivation and an appreciable amount of moisture is present within a package, leeching of P2O5 from the glassivation can occur, resulting in the formation of phosphoric acid. The phosphorus in the glass acts as a getter (collector) for mobile sodium ions.

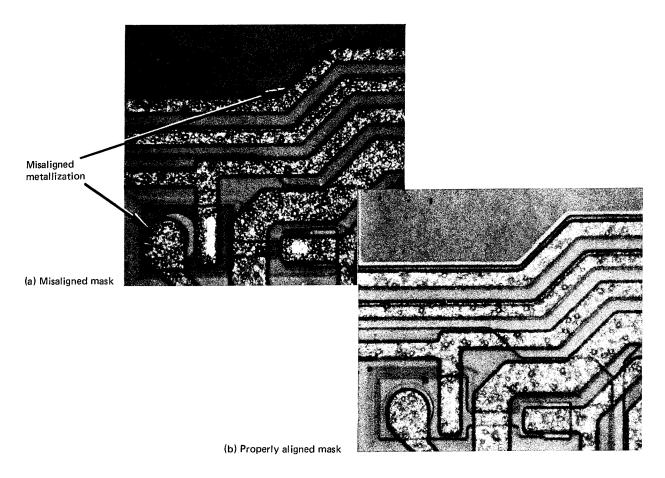
As stated previously, the photolithographic process can be the source of many errors during integrated circuit fabrication. Another defect that can occur to the metallization during the photolithographic process is misalignment. Misalignment occurs when the mask used to produce the metallization pattern becomes misaligned with the contact windows on the silicon die (fig. 21), with the result that the contact windows have reduced metallization coverage. In addition, interconnection stripes on the die may pass over areas that were not intended to be covered by metal. For example, unintended metal coverage over a thin-film capacitor could make a device more susceptible to electrostatic discharge than a device that is properly constructed. This is the case in figure 21,

Figure 21. Photomicrographs of metallization alignment.

where a misaligned mask resulted in a system failure. Contact windows that are not completely covered by metallization can result in latent device failure. The small part of the contact window covered by metallization could develop a hot spot when a high current density is flowing through the contact. Electromigration could open-circuit the metal after a period of time.

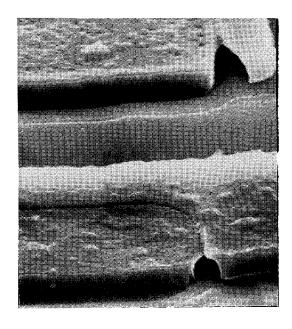
Figure 22. Incomplete metallization coverage of contact windows.

- Less than 75 percent of the area of the contact window is covered by metallization (fig. 22).
- Less than a continuous 50 percent of the perimeter of the contact window is covered by metallization.

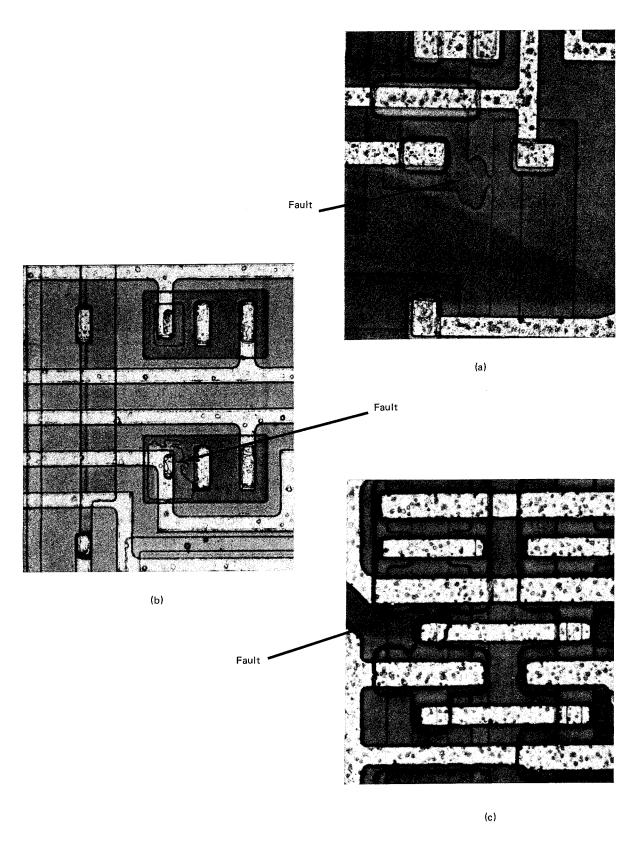
Diffusion, passivation, and dielectric isolation faults are normally the result of defects or inconsistencies in the photolithographic process. Two diffusion-type faults are of most concern in precap visual examinations. Any diffusion fault that allows bridging between diffused areas is unacceptable (fig. 24a). Faults like this can be traced to lifting and peeling of the photoresist, causing exposure irregularities. These faults could manifest themselves as resistive short circuits between two diffused areas. Figures 24a and 24b show some diffusion irregularities.

Figure 24. Diffusion faults.

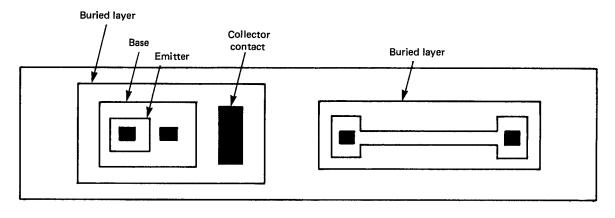
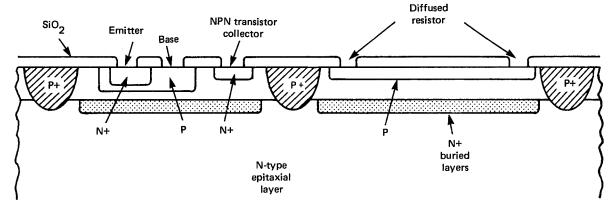
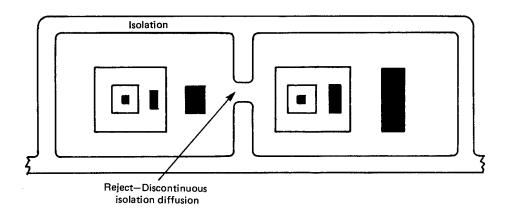
Figure 25. Junction isolation.

The second type of diffusion fault deals with junction isolation. In integrated circuit design, junction isolation (fig. 25a) can be used to prevent undesired electrical interconnection between regions in the same silicon substrate. These isolation areas are formed by the diffusion process. Processing faults can cause a discontinuity in the isolation diffusion. If this occurs, adjacent isolated areas are short-circuited (fig. 25b). This is an unacceptable defect. Even if the isolation diffusion is continuous, it can be reduced in width. If sufficiently reduced in width, the depletion layers of the isolated regions could spread far enough to touch each other. Similar defects (reduction in width) can also occur in diffused resistors. This changes the resistance of the resistor and might affect the circuit operation only under unusual circumstances that are not normally covered during electrical testing. Some of the rejection criteria for diffusion faults are:

- Any isolation diffusion that is discontinuous.
- Any diffused area with less than 25 percent of the original diffusion width.
- Any diffused resistor with less than 50 percent of the original diffusion width.

(b) Visual criteria for discontinuous isolation diffusion

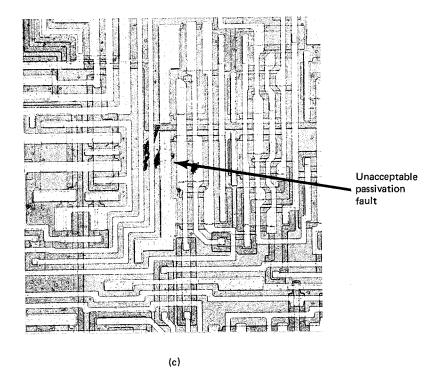
Figure 26. Faults in silicon dioxide passivation (c and d).

Passivation faults are defects in the silicon dioxide that are detectable by a thinning or absence of passivation (silicon dioxide). Masking problems are the major contributor to passivation faults. Passivation faults become rejectable when they exist underneath metallization stripes (fig. 26). If the passivation fault is deep enough, the metallization could short circuit underlying conductors or even the silicon substrate. The depth of the passivation fault can be estimated by the number of lines observable at the edge of the fault. Even though the depth of the fault does not cause short circuits, the oxide may be thin enough to break down during electrical operation over the life of the device.

Unacceptable passivation fault

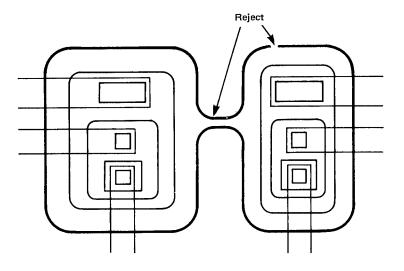
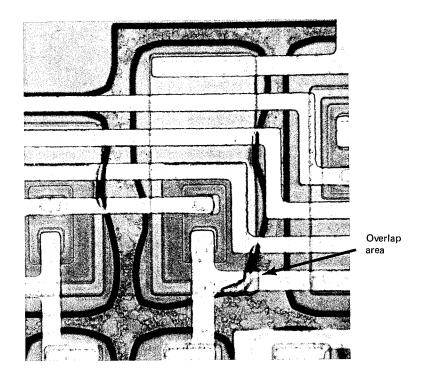
(a) Visual criteria for isolation lines

Some manufacturers use a process called dielectric isolation to isolate individual active circuit elements. Each circuit element is surrounded on the sides and bottom by an insulating layer of silicon dioxide (fig. 27). If problems occurred during processing due to masking faults, isolation regions could be bridged, resulting in a short circuit between active regions. This type of fault is detectable by the absence of a continuous isolation line (fig. 28a) between adjacent active areas. (Each active area is in reality a diffusion tub.) The isolation line is typically a black line whose discontinuity is easily recognized. A similar rejectable defect is a discontinuous isolation around each active area. Diffusions that are made into an active tub area are sometimes offset because of small alignment problems. Defects such as this are rejectable if an overlapping diffused area comes closer than 0.1 mil to an adjacent tub or an overlap of more than one diffusion into the dielectric isolation material occurs (fig. 28b).

(b) Two diffusions overlapping into the dielectric material

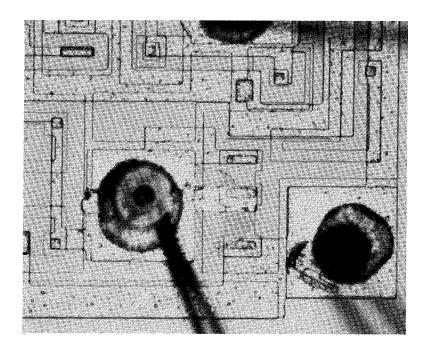
At times during the manufacturing process, a defect occurs in the mask used to generate the glassivation pattern, or the photoresist does not adhere properly. When this occurs, areas of metallization on the die are left uncovered by glassivation. If two or more active adjacent metallization stripes are left uncovered, the device is rejectable (fig. 29). Uncovered active areas of metallization can be resistively short-circuited if conductive particles come to rest in the area.

Figure 29. Two active adjacent metallization stripes not covered by glassivation.

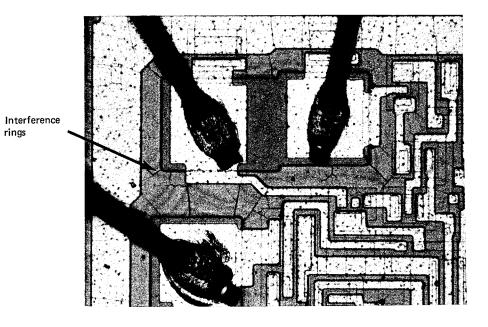
Figure 30. Cracks in the glassivation. Note the interference rings in (a), indicating lifted glassivation.

can occur (fig. 30). Poor adhesion of the glassivation can result from improper cleaning of the die surface during processing. In these areas of poor adhesion, the glassivation can crack enough to form closed loops over adjacent metallization stripes. This is considered to be rejectable because the glassivation could peel off in this area, allowing the two adjacent exposed stripes to become short-circuited by loose particles inside the package.

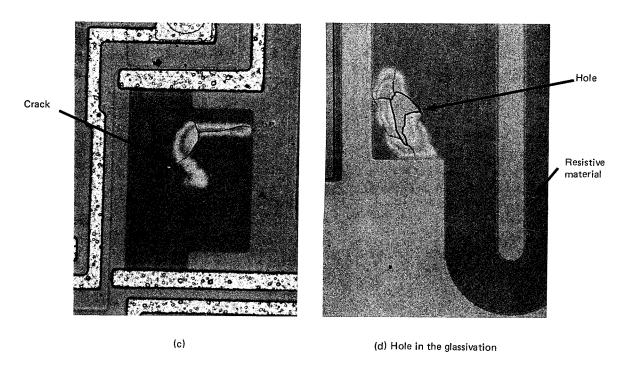
cuits requires that resistor trimming take place after PSG deposition. Trimming is performed by a laser, and if the power output of the laser is too high, the heat produced during trimming can crack the glass (fig. 31). High moisture content within a package can enter through the cracks and can be absorbed by the resistor material. This moisture subsequently changes the electrical characteristics of a highly trimmed circuit. For this reason, circuits that exhibit crazing, voids, and cracks in the glassivation over thin-film resistors are rejectable.

Figure 31. Cracks in the glassivation over thin-film resistors.

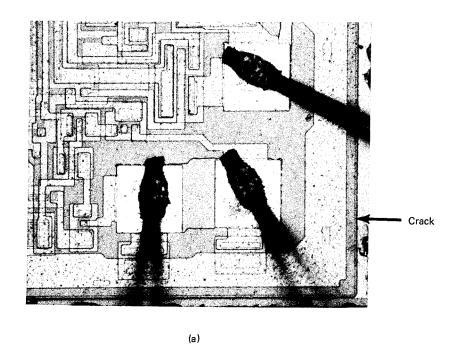
Figure 32. Cracks in the scribe grid of a die.

Unless proper lighting is used during precap screening, devices with cracks can sometimes look acceptable. Figure 32a shows cracks in the scribe area under normal bright-field lighting. Note that some of the cracks come too close to active operating metallization to be acceptable. If phase-contrast lighting is used, the actual extent of the crack can be seen (fig. 32b). A defect of this type is rejectable. In the course of normal precap examinations, however, the time required for individual microcircuit attention such as that described above usually cannot be spared. Figure 33 illustrates the rejection criteria for cracks, and figure 34 shows cracks in dice.

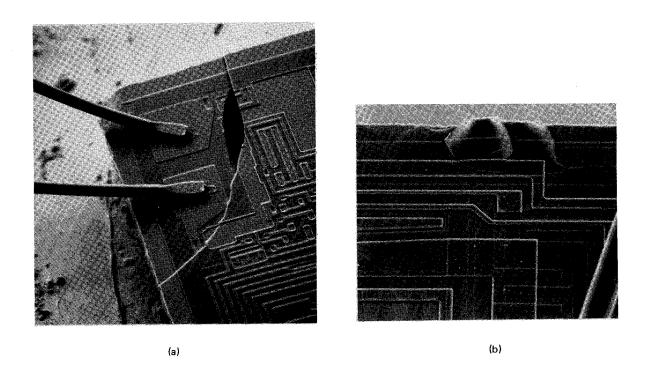
Figure 34. Scanning electron micrographs of unacceptable cracks in two dice.

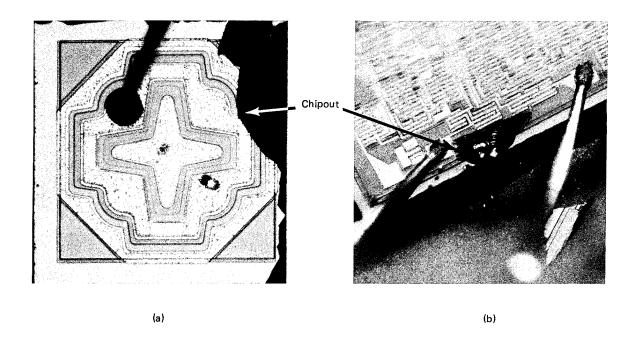
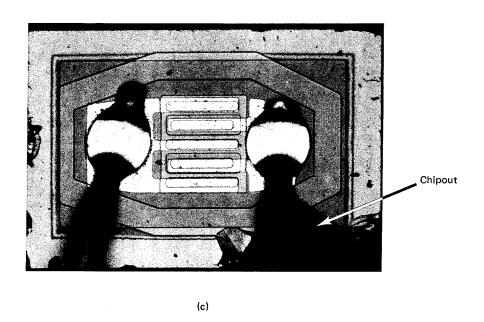
Other defects that can occur in the scribing operation are chipouts in the die. Chipouts occur when the wafer has not been completely scribed. In the subsequent breakup of the wafer, the silicon fractures rather than breaking cleanly along the scribe line. Chipouts can also occur during subsequent handling operations (fig. 35b), such as when the die is being mounted inside the package. The photographs in figure 35 show some rejectable chipouts in dice. Figure 36 illustrates the rejection criteria for chipouts.

Figure 35. Unacceptable chipouts in semiconductor dice.

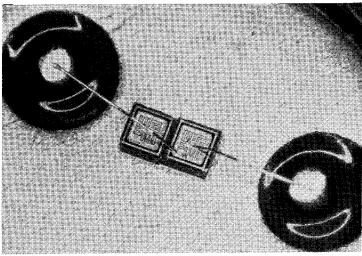
If the wafer is not aligned properly during the scribing operation, scribing takes place along some plane other than the scribe grid. When this occurs, some dice will have attached portions of active circuit area of other dice—a rejectable defect (fig. 37).

Figure 37. Semiconductor dice that have attached portions of the active circuit areas of other dice.

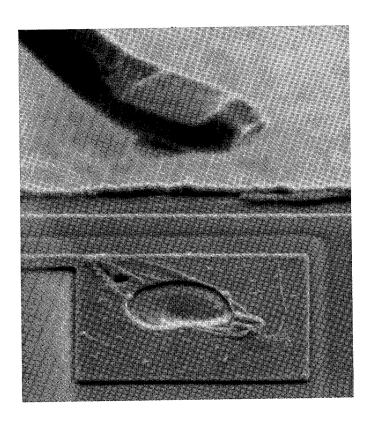
Figure 42. Scanning electron micrograph of cratering that occurred underneath a wedge bond.

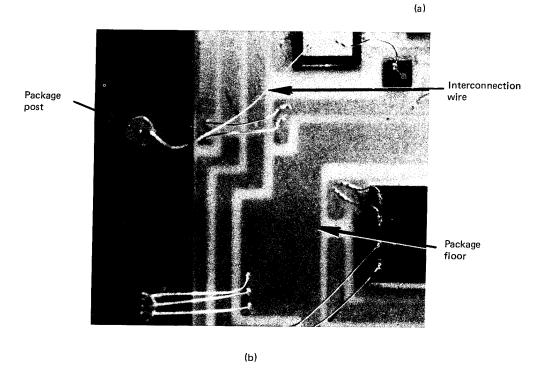
Figure 50. Excessive looping of interconnection wires.

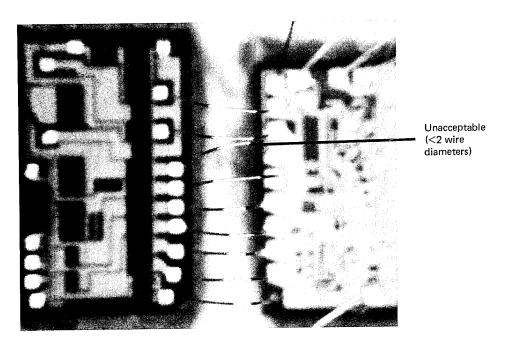
Figure 51. Interconnection wires passing within 2 wire diameters of each other.

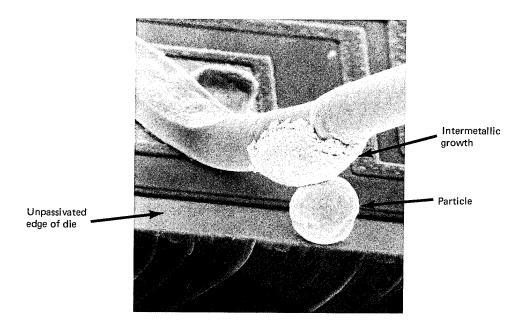
Figure 53. Scanning electron micrograph of a gold particle shorting an interconnection lead to the unpassivated die edge. Note the intermetallic that has grown as a result of the short.

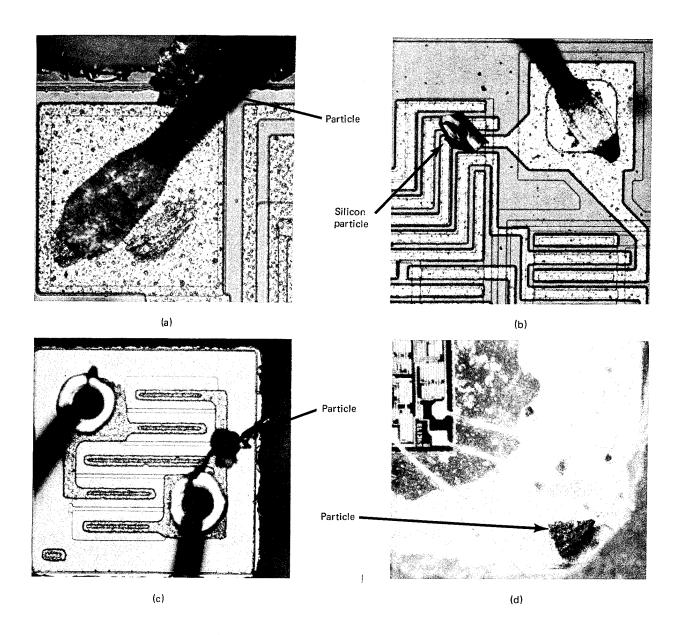
Figure 57. Foreign particles inside packages.

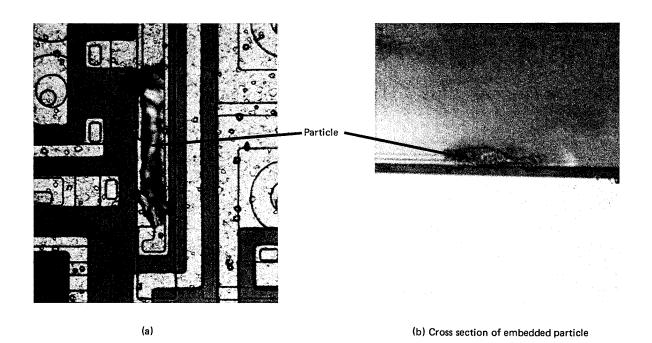
Figure 58. Conductive foreign particles embedded in the glassivation.

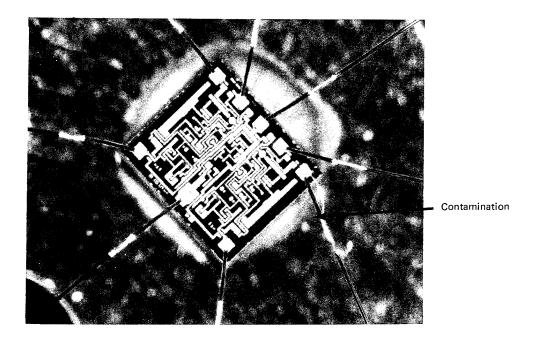
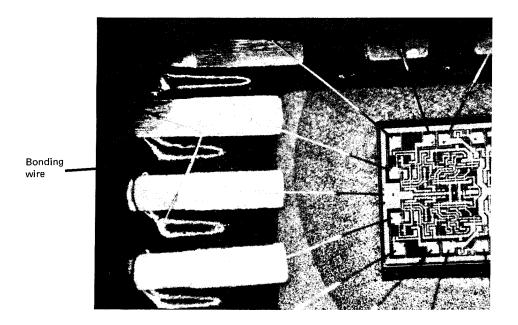
(a) Particle of lint

(b) Loose piece of bonding wire

Figure 59. Particulate contamination.

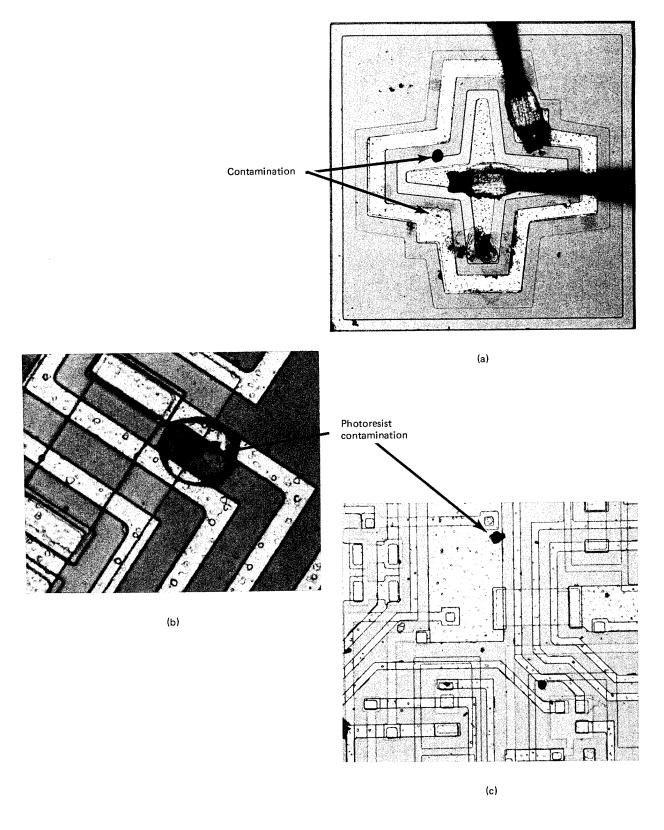
Figure 60. Chemical stains on the surfaces of dice.

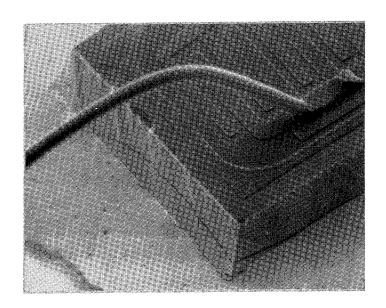
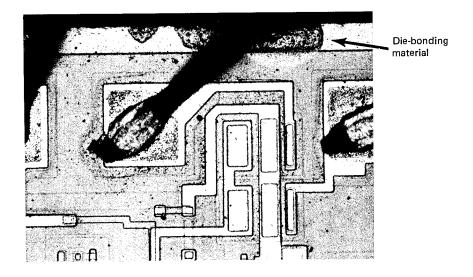
(a) Lifted die

(b) Scanning electron micrograph of a cracked die

Figure 62. Die-bond anomalies.

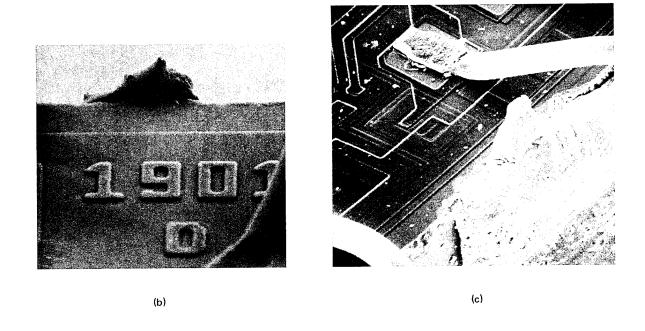
Figure 63. Unacceptable conditions of die-mounting material.

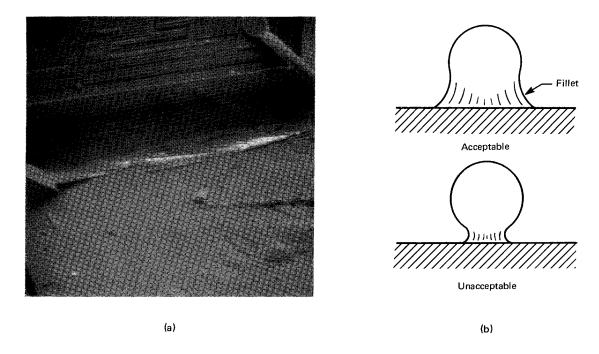
Figure 64. Anomalies concerning the die-attach material.

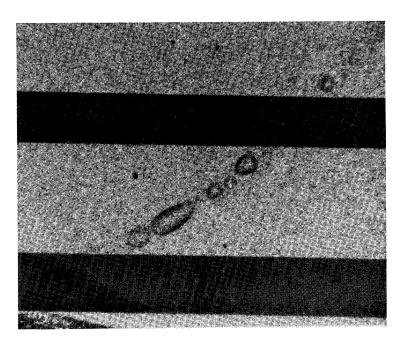
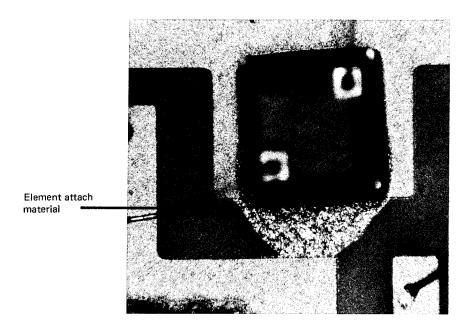
(a) Unacceptable scratch

(b) Poor adherence

Figure 66. Metallization defects on a hybrid substrate.

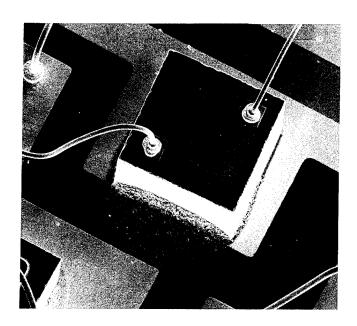
(a) Runout of element attach material that leaves less than 1-mil separation

Figure 67. Hybrid defect.

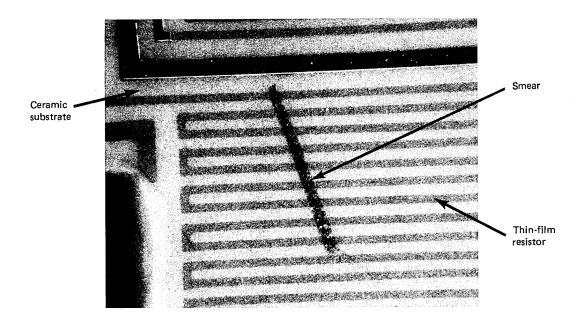
Figure 72. Smear in a thin-film resistor that has been deposited on a ceramic substrate.
